**Docket No. 217 – Development and Management Plan Inspection**

**Date:** December 22, 2004

**Location:** Norwalk Substation Expansion

**Location:** Plumtree Substation Expansion , Bethel

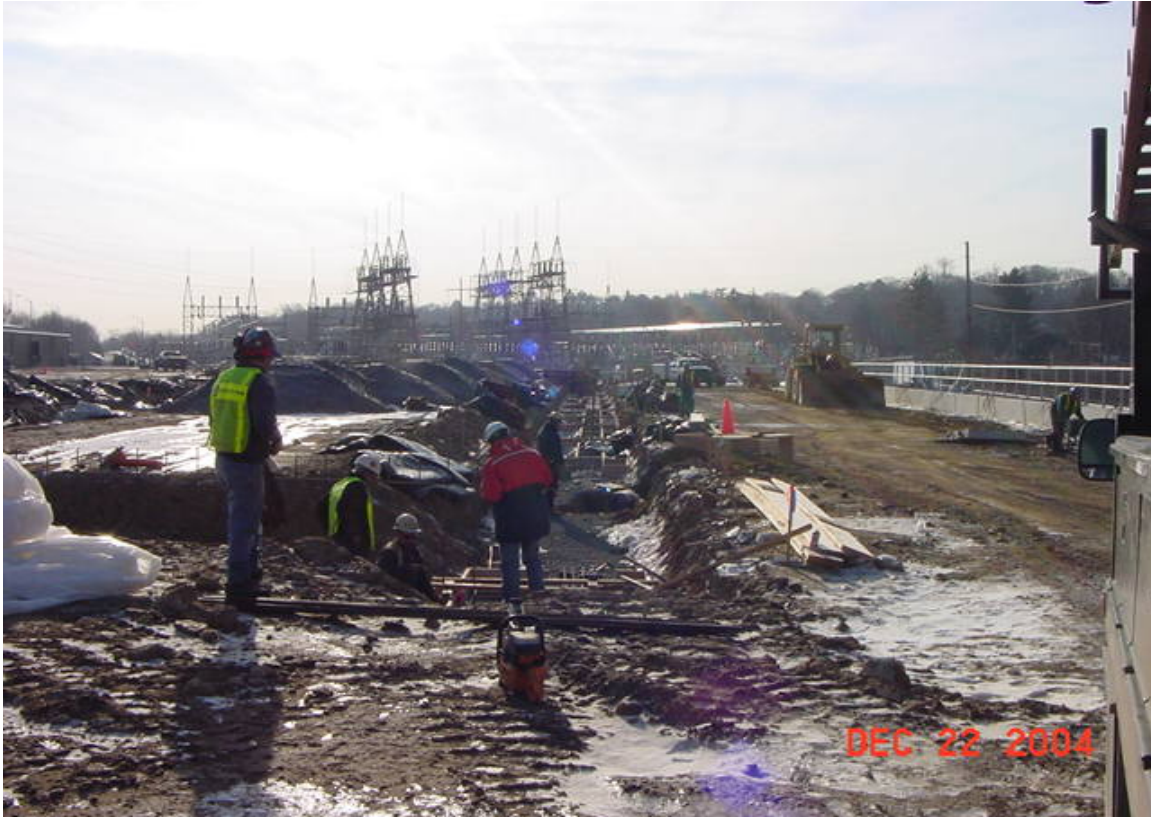
View of the excavation and construction of the footings of the GIS building. All soil is well contained within the site. 12/22/04

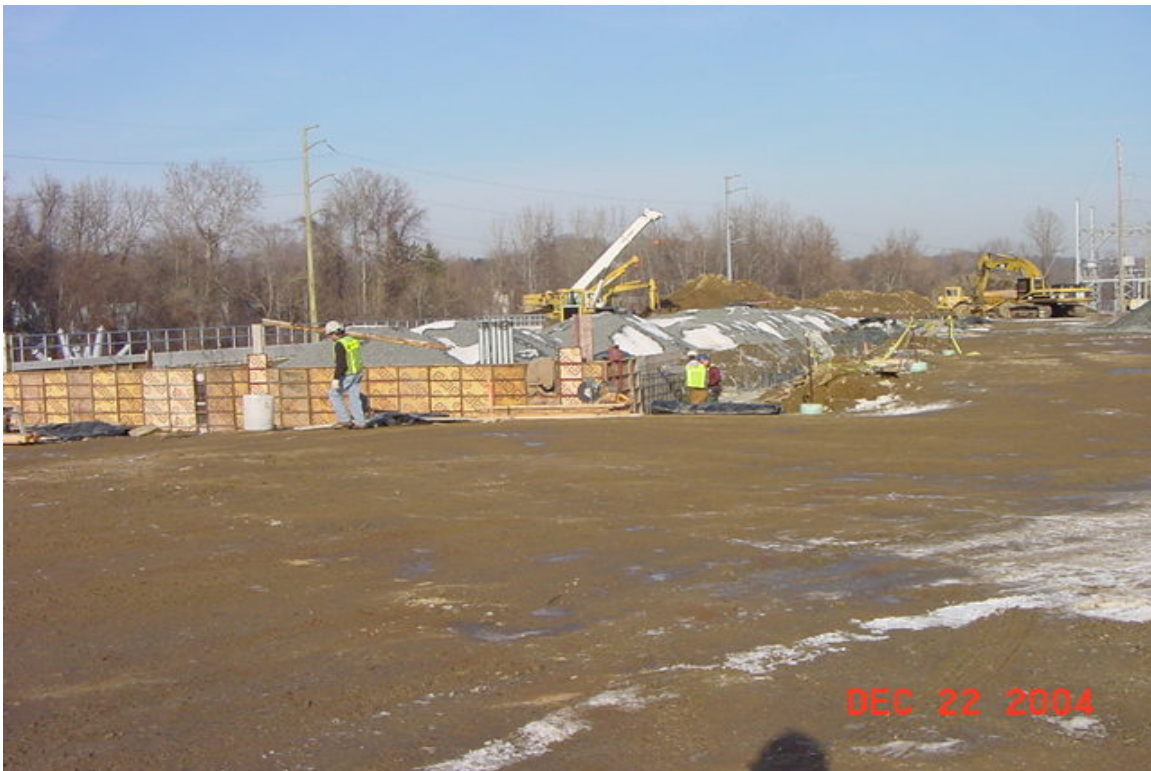
View of the forms being set for the GIS building. 12/22/04

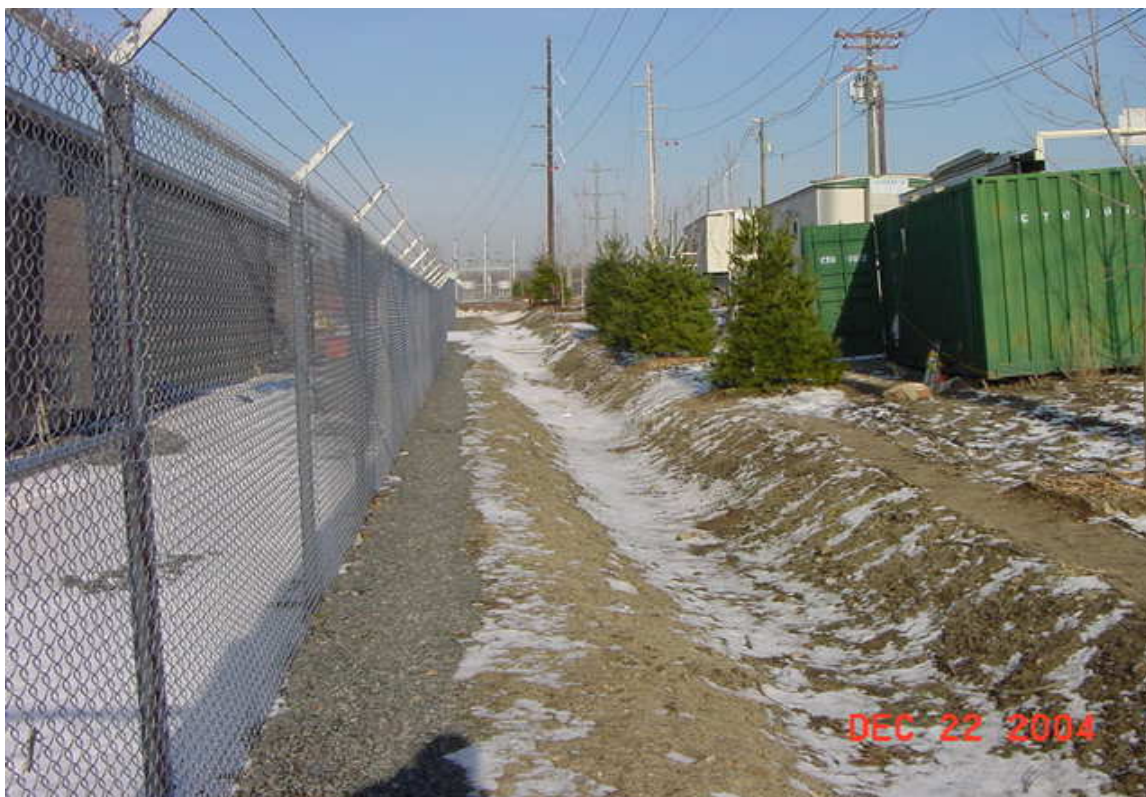
- Some gullies remain on the slopes of the ditch along the perimeter fence and Rt 7 ramp, but the ground is now frozen and currently stabilized. 12/22/04	- Monitor the swale for effectiveness during rain events and determine whether further stabilization is necessary. 12/16/04-12/22/04
	-Winter frost has set in and except for occasional thawing areas should remain fairly stable until Spring.12/22/04	-Continue to monitor. In the Spring the situation should be evaluated as additional seeding may be necessary. 12/22/04
Inland Wetland and Watercourse encroachment and mitigation	- Silt fence has been removed from most areas along the wetland/river side of the channel as the area is stabilized. 12/16/04	-None at this time. Continue to monitor. 12/16/04-12/22/04
State species of concern, threatened and endangered species	- No species of concern are located in this area of construction.	- N/A
Vegetative clearing limits (including trees to save or danger trees noted)	-Some plantings along the channel were flagged for damage to see how they survive the winter. 11/18/04	- The plantings will be evaluated for any permanent damage in the spring and hydroseed was placed as ground cover here. 11/18/04

View of the ditch along the perimeter fence. Frost has set in and the slopes are more stable for now, however, establishment of vegetative cover for stabilization should be monitored in the spring. 12/22/04

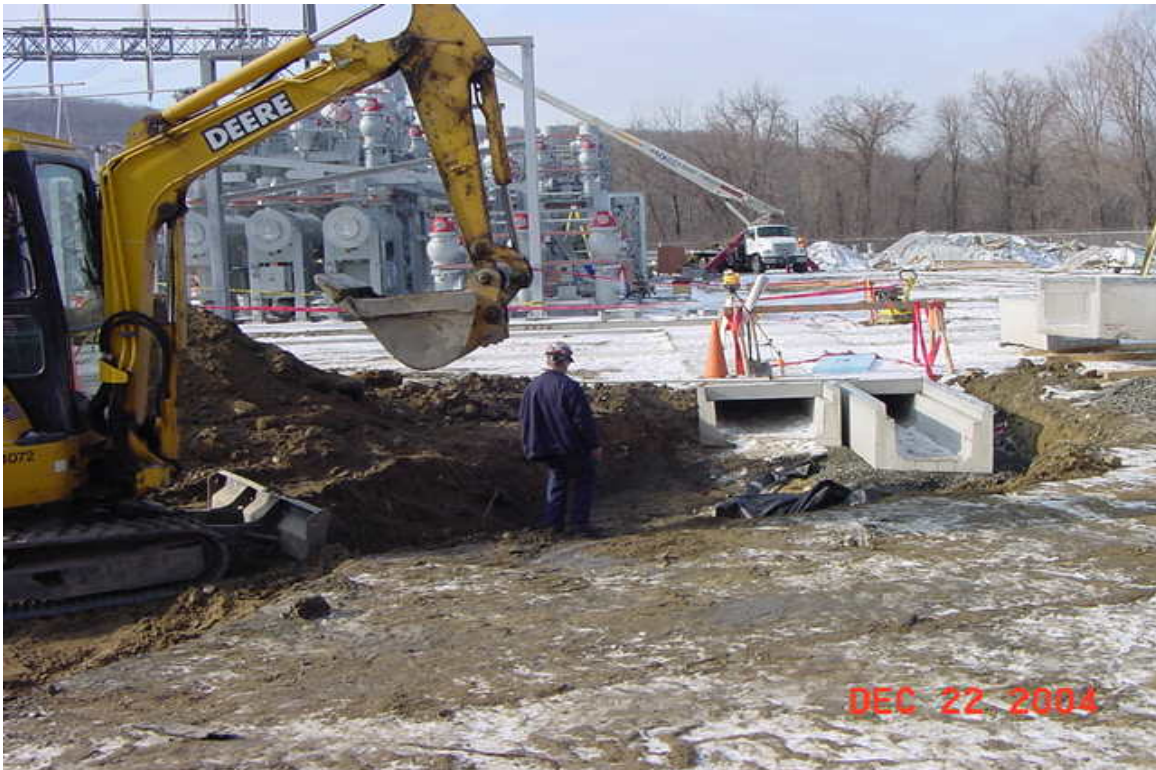
Plumtree Substation: Work continues on minor excavation/installation of cable trenches adjacent to the concrete slab. 12/22/04

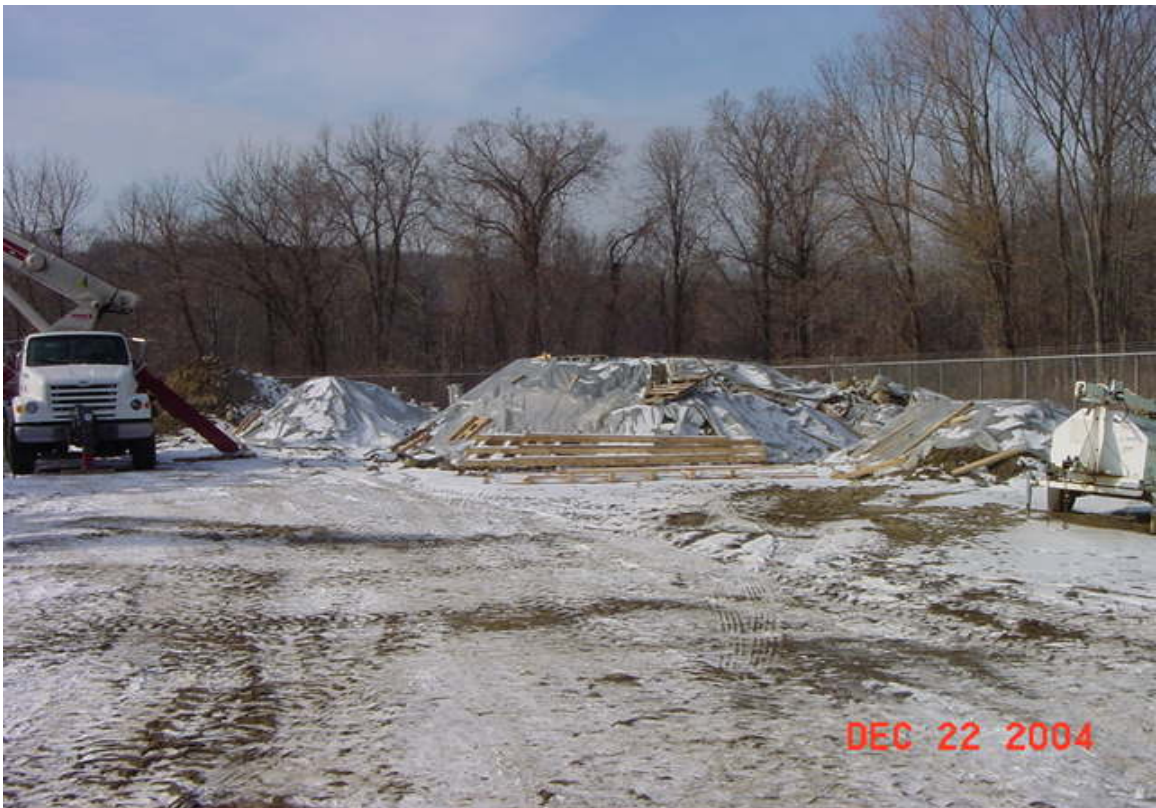
- There is no silt fence in place at this time, however major stockpiles are covered in plastic following the end of each work day. 9/16-12/22/04	-All areas are well-contained and there is no sedimentation near any off site areas. 12/22/04

The yard is partially frozen and snow covered. Stockpiles continue to be covered in plastic when not actively in use. 12/22/04
